Improper Use of Storefront Window Systems Leading to Costly Repairs – A Case Study

Written by Jason Popovich of Inspec

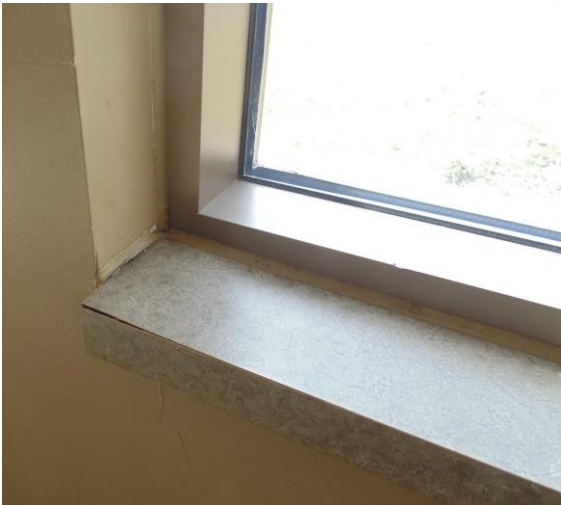
Figure 1. Visible moisture damage of the plastic laminate sills . (Courtesy Inspec)

Early 2021, a Minneapolis, Minnesota-based church began to get frustrated after experiencing years of issues dealing with water infiltration below their windows, which caused visible damage to the sills. The sills, which were made of plastic laminate, had begun to swell as they took on water

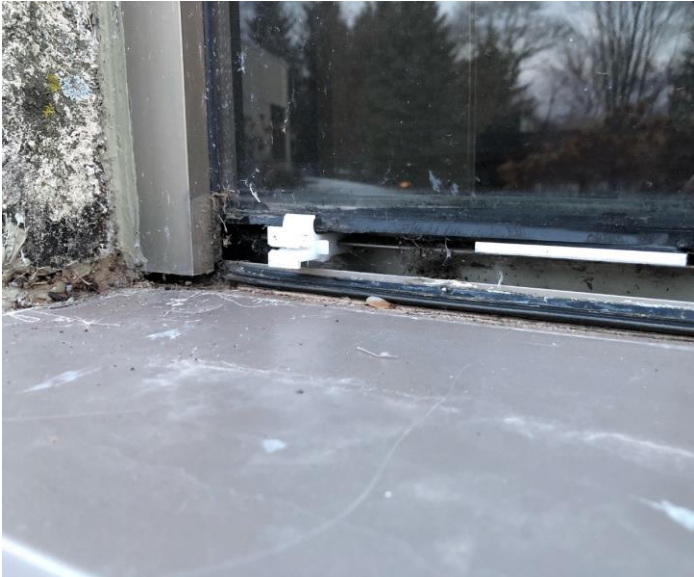
Figure 2. Plastic clips secure the aluminum to the glazing gaskets, allowing movement and water entry. (Courtesy Inspec)

Storefront systems are designed to control water, not be waterproof. In general, storefront systems manage water within the frame and therefore need extra steps to direct that water back to the exterior at the sill. During a storm, the positive or negative pressures on a building will cause the glass panes to push away from the glazing gaskets, allowing water to penetrate the system. The plastic clips, seen in **Figure 2** of the church's storefront system, secure the exterior aluminum with the glazing gaskets, allowing the aluminum to move. This causes gaps in the gasketing, allowing water to enter the mullion system. This water then needs to be managed.

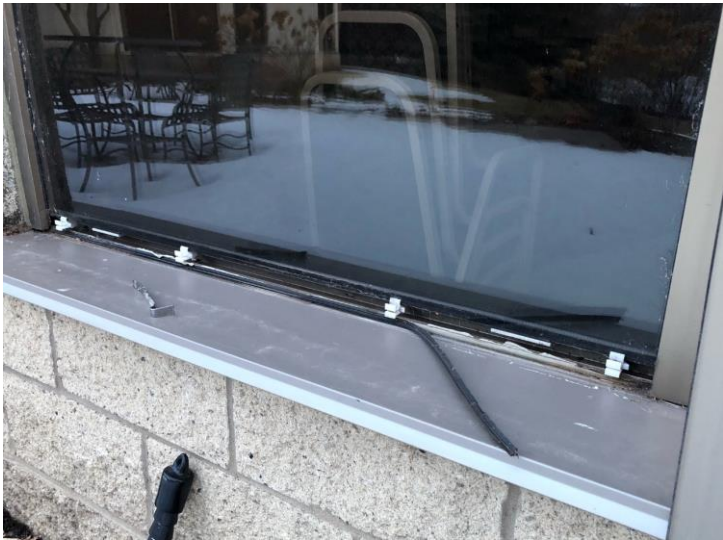
Figure 3 - the frame of the windows did not incorporate a sill pan to direct water to the exterior. The flashing shown stops at the front of the window where it met the gasketing and no end dams were incorporated. Also evident is the previous attempt to seal from the outside where the flashing meets the gasketing. (Photo courtesy Inspec)

In proper application, the water will drain down vertical mullions where it collects at the sill. An installed sill pan collects and diverts the water to the exterior where it is drained through a series of weeps. This method is similar to gutters and downspouts of a roof system. Given the method of water expulsion, there can be confusion as to where the primary seal is on a storefront system. Many think that it is the exterior seal, but because the system is designed to allow a certain amount of water to travel within the frame where it is managed, the primary seal is on the interior and is very critical to the watertightness of the window system (**Figure 3**). This requires the proper design of sill pans, end dams, and flashing at the bottom to catch and divert water to the exterior pertinent to preventing water from entering the building.

Upon removing the trim, it was evident there was no sill pan beneath the frame to direct intruded water that runs down the vertical channels back to the exterior (**Fig 3**). The flashing over the sloped block on the exterior terminated at the front of the sill where the gasketing is located. Without a sill plan and end dams, water within the system was able to enter the interior space below the sill. The previous attempts to seal from the outside further limited moisture within the system from escaping.

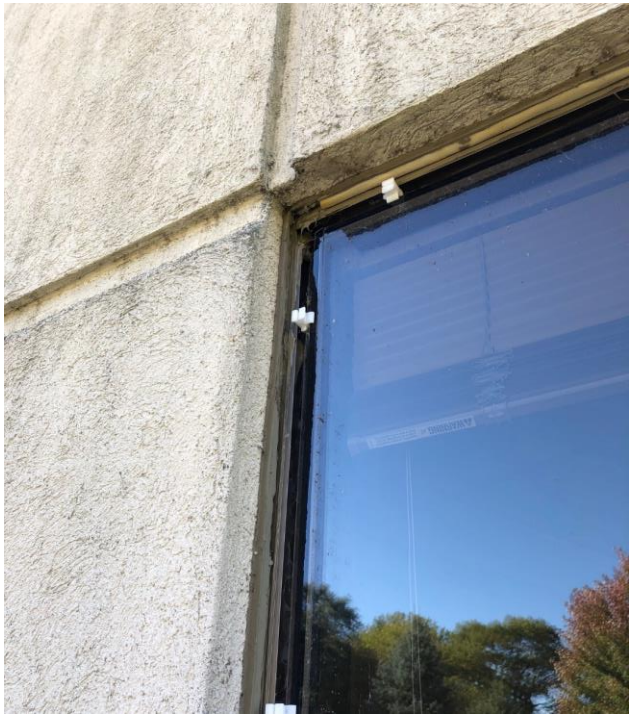
Figure 4 – No existing weep holes, which provide drainage of water to the exterior, were evident. (Courtesy Inspec)

Even if water is directed to the exterior, there still needs to be a means for it to escape. Therefore, proper weeps need to be incorporated. Further review of the church windows also showed a lack of existing weep holes (as seen in **Figure 4**).

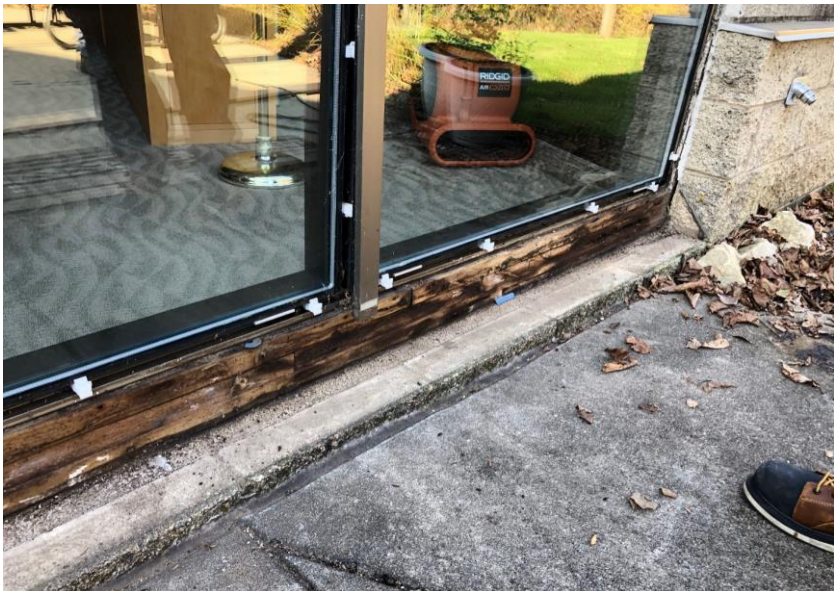
Figure 5 – Storefront system lacking proper sill pan and end dams allowed water to escape into the wall below the sill, causing damage to stacked wood framing. (Courtesy Inspec)

The lack of the proper collection and drainage system was determined to be the cause of the initial water infiltration. The addition of sealant to the exterior further limited the drainage of water. These combined factors resulted in an abundance of water which collected below the sill, leading to the damage to the sills and the framing below.

To complicate matters more, the storefront windows located on the ground floor were simply wrapped with aluminum cladding. Considering the storefront windows located in this area were close to the finished grade, they were also susceptible to additional moisture from surface run off. Lacking any protective membrane or other means of waterproofing resulted in even more extensive damage to the stacked wood frames, as evident in **Figure 5**.
